**Flood Control Project Maintenance
Levee Inspections**

Maintenance Issue Types Only, Levee Inspection Report By Mile - Spring 2018

Reclamation District No. 0524 Middle Roberts Island

Waterway	Bank	Unit Miles	Inspection Start/End	Inspector
Unit No. 01 San Joaquin River	Left	6.20	04/24/2018 04/24/2018	Richard Willoughby

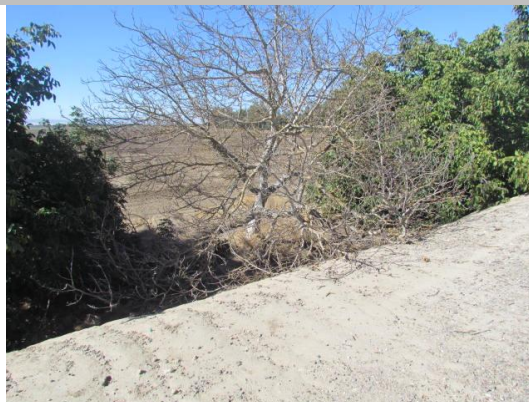
Photo 1 of 1 : SP_2018_RD0524_107_199_20180323_00278.jpg

LM Start	4.42	Rating **	M	Issue No.	199
LM End	4.42	Issue Type +	Ma	Location *	LS
Category	Earthen Levee			GPS Latitude/Longitude	
				Start	End
Item	Encroachments			37.893659 °	37.893659 °
				-121.329092 °	-121.329092 °
DWR ID	DWR_RD0524_01_f_2015_199				
Comment Code					
TR : Tree or limb					
Inspector Comment					
Remove dead tree from landside toe.

Looking west at dead tree on landward slope and toe fall 2015.

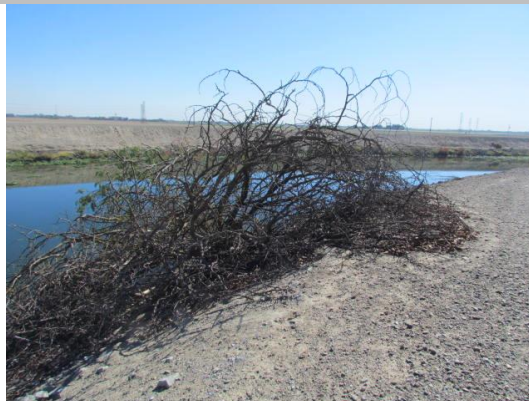
Photo 1 of 2 : SP_2018_RD0524_107_102_20180323_00186.jpg

LM Start	4.52	Rating **	U	Issue No.	102
LM End	4.52	Issue Type +	Ma	Location *	WS
Category	Earthen Levee			GPS Latitude/Longitude	
				Start	End
Item	Encroachments			37.892383 °	37.892383 °
				-121.328194 °	-121.328194 °
DWR ID	DWR_RD0524_01_f_2016_102				
Comment Code					
TR : Tree or limb					
Inspector Comment					
Dead tree on waterside slope.

Looking southeast at dead tree on waterside slope fall 2015

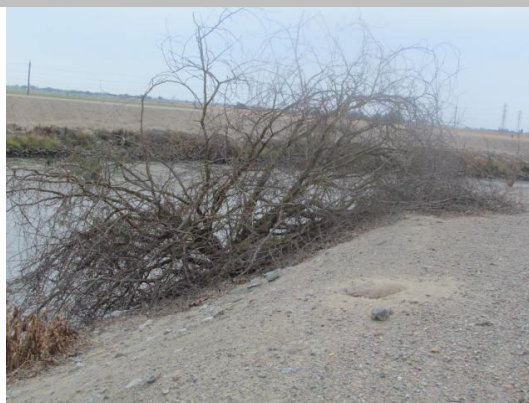
Photo 2 of 2 : SP_2018_RD0524_107_102_20180323_00187.jpg

Looking southeast at dead tree on waterside slope.

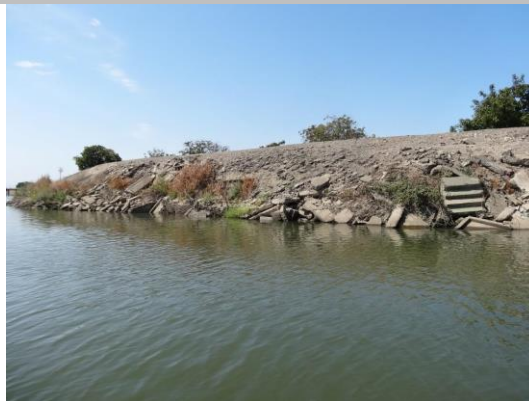
Photo 1 of 3 : SP_2018_RD0524_107_90_20180323_00172.jpg

LM Start	4.53	Rating **	A/W	Issue No.	90
LM End	4.54	Issue Type +	Ma	Location *	WS
Category	Supplemental			GPS Latitude/Longitude	
				Start	End
Item	DWR Erosion Survey			37.892230 °	37.892230 °
				-121.327930 °	-121.327930 °
DWR ID	RD0524U01RM45.07				
Comment Code					
Inspector Comment					
09/13/2017: No significant change observed. 07/25/2016: No significant change observed. 06/24/2015: No significant change observed. 06/19/2014: No significant change observed. 08/13/2013: No significant change observed. 08/07/2012: The erosion is located at the inside of a river bend. Site is covered with broken concrete blocks and other debris. [2017 Site ID:RD0524U01RM45.07]

Front view of the erosion site.

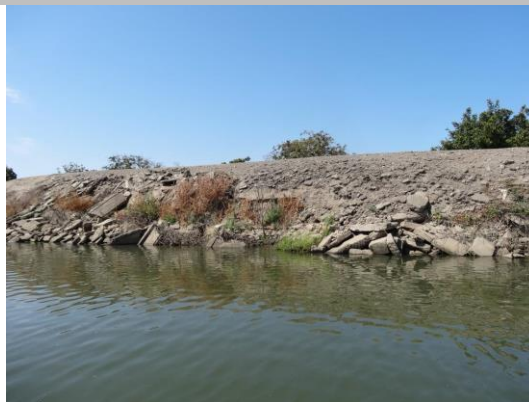
Photo 2 of 3 : SP_2018_RD0524_107_90_20180323_00173.jpg

Close view of the site.

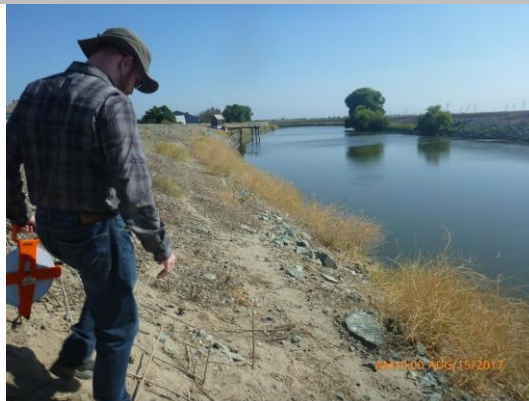
Photo 3 of 3 : LEVAL_SP_2018_523_4219.jpg

LM Start	4.76	Rating **	A/W	Issue No.	236 (cont)	
LM End	4.76	Issue Type +	Ma	Location *		
Category	Supplemental			GPS Latitude/Longitude		
				Start	End	
Item	2017 Storm Damage			37.889300 °	37.889300 °	
				-121.329800 °	-121.329800 °	
DWR ID	DWR_RD0524_01_f_2017_236					
Comment Code						
Inspector Comment						
Levee Evaluation Comments						
Description:Slope protection repairs are needed along the waterside slope due to erosion and riprap displacement from high water. Based upon levee inspections, it was determined the waterside levee slope is eroding, deteriorating, and degrading. The eroded levee sections need to be restored back to design standards to prevent further deterioration and damage.						
Site ID No:523						
Site Designation:LMA-429						
Repair Type: Erosion						
Rating:Area of Concern						
Field Date:8/15/2017						
Notes:

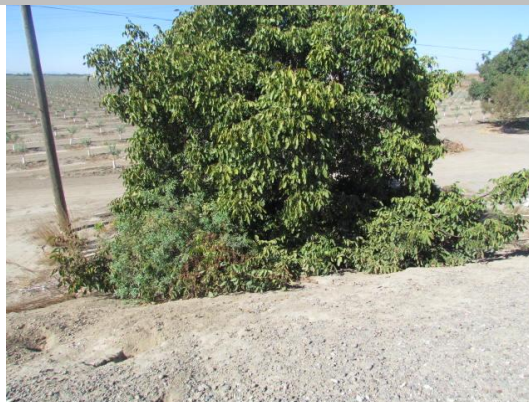
Photo 1 of 1 : SP_2018_RD0524_107_84_20180323_00168.jpg

LM Start	4.90	Rating **	U	Issue No.	84
LM End	4.93	Issue Type +	Ma	Location *	LS
Category	Earthen Levee			GPS Latitude/Longitude	
				Start	End
Item	Trim / Thin Trees			37.887613 °	37.887258 °
				-121.331161 °	-121.331596 °
DWR ID	DWR_RD0524_01_s_2012_84				
Comment Code					
T1 : Trim trees to at least five feet above ground level.					
Inspector Comment					
Untrimmed trees on landside slope.

Looking west at untrimmed tree on landward slope.

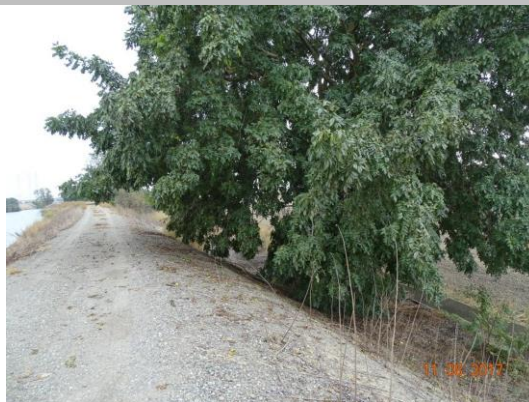
Photo 1 of 1 : SP_2018_RD0524_107_260_20180323_00362.jpg

LM Start	5.00	Rating **	M	Issue No.	260
LM End	5.00	Issue Type +	Ma	Location *	LS
Category	Earthen Levee			GPS Latitude/Longitude	
				Start	End
Item	Trim / Thin Trees			37.886367 °	37.886367 °
				-121.332047 °	-121.332047 °
DWR ID	DWR_RD0524_01_f_2017_260				
Comment Code					
T4 : Trim trees over roadway to at least 12 feet above ground level.					
Inspector Comment

Looking southwest at the landside slope.

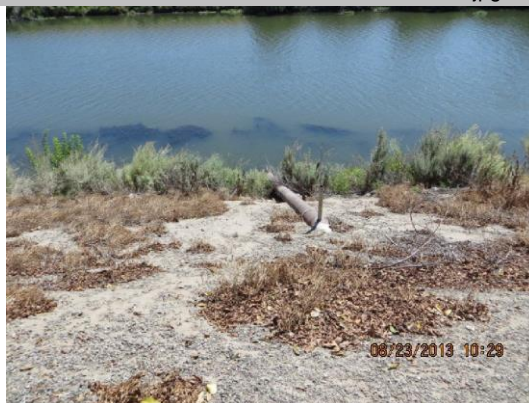
Photo 1 of 3 : UCIP_SP_2018_51633_30689.jpg

FS_ID:51633
DS_ID:20630
EP_NO: N/A
Repair Type: Urgent
Crossing Status: Found
UCIP Comments: 11/16/2016 same as previous inspection hole in pipe is still present on WS near toe. This pipe does not appear to be in use. Need to contact owner to determine status of crossing. If the crossing is abandoned or still in use, owner will need to coordinate with the CVFPB to comply with Title 23 requirements. (O. Magana - DWR UCIP)08/23/2013 flap gate damage and does not work at WS toe. Large hole in pipe at WS toe. Pipe appears abandoned and should be done so properly. (W. Wylie - DWR UCIP)
FIELD_STRUCT_DESC: *ABANDONED* 1 of 2: 12-inch steel irrigation pipe through the levee, 6 feet below the crown. Pump located on the waterside (WS), no pump found in 2013. Flap gate located on the WS end. [Additional Reference(s): DWR Levee Log, 2004. USACE San Joaquin O&M Manual 7, April 1964, (HLM 5.48) 10-inch pipe listed, Drawing No. 07-04-1490, Sheet 1490/4, (Station 8+01.3)].

Pipe visible on WS slope.

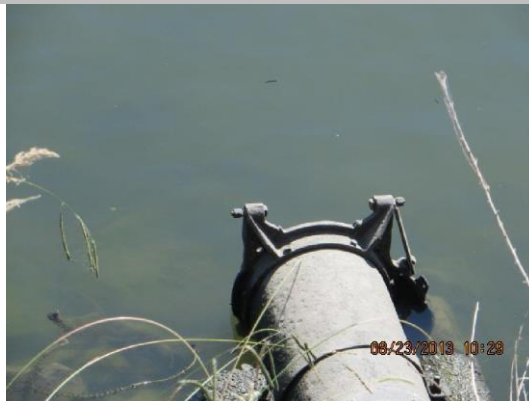
Photo 3 of 3 : UCIP_SP_2018_51633_30687.jpg

FS_ID:51633
DS_ID:20630
EP_NO: N/A
Repair Type: Urgent
Crossing Status: Found
UCIP Comments: 11/16/2016 same as previous inspection hole in pipe is still present on WS near toe. This pipe does not appear to be in use. Need to contact owner to determine status of crossing. If the crossing is abandoned or still in use, owner will need to coordinate with the CVFPB to comply with Title 23 requirements. (O. Magana - DWR UCIP)08/23/2013 flap gate damage and does not work at WS toe. Large hole in pipe at WS toe. Pipe appears abandoned and should be done so properly. (W. Wylie - DWR UCIP)
FIELD_STRUCT_DESC: *ABANDONED* 1 of 2: 12-inch steel irrigation pipe through the levee, 6 feet below the crown. Pump located on the waterside (WS), no pump found in 2013. Flap gate located on the WS end. [Additional Reference(s): DWR Levee Log, 2004. USACE San Joaquin O&M Manual 7, April 1964, (HLM 5.48) 10-inch pipe listed, Drawing No. 07-04-1490, Sheet 1490/4, (Station 8+01.3)].

Broken flap gate at WS toe.

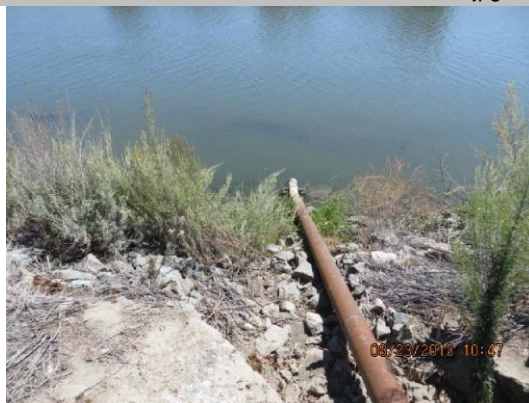
Photo 3 of 3 : UCIP_SP_2018_18348_30704.jpg

LM Start	5.42	Rating **	M	Issue No.	963 (cont)	
LM End	5.42	Issue Type +	Ma	Location *		
Category	Supplemental			GPS Latitude/Longitude		
				Start	End	
Item	DWR UCIP LMA Responsibility			37.880358 °	37.880358 °	
				-121.332972 °	-121.332972 °	
DWR ID						
Comment Code						
Inspector Comment						
FS_ID:18348						
DS_ID:20631						
EP_NO: N/A						
Repair Type: Non-Urgent						
Crossing Status: Found						
UCIP Comments: Recent work being done on WS slope. Pipe may still be in use.						
FIELD_STRUCT_DESC: 10-inch steel drainage pipe through the levee, 6 feet below the crown. Pump not found on the landside (LS).						
[Additional Reference(s): DWR Levee Log, 2004. USACE San Joaquin O&M Manual 7, April 1964, (HLM 5.50)].						
FS Date: 8/23/2013

No flap gate on end of pipe at WS toe.

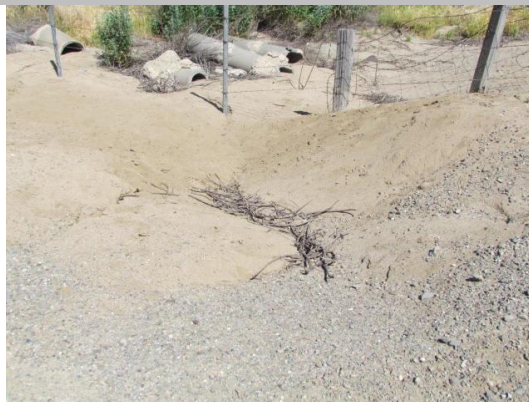
Photo 1 of 3 : SP_2018_RD0524_107_118_20180323_00202.jpg

LM Start	5.42	Rating **	M	Issue No.	118
LM End	5.42	Issue Type +	Ma	Location *	LS
Category	Earthen Levee			GPS Latitude/Longitude	
				Start	End
Item	Slope Stability			37.880323 °	37.880323 °
				-121.332968 °	-121.332968 °
DWR ID	DWR_RD0524_01_s_2012_118				
Comment Code					
S1 : Repair slope instability.					
Inspector Comment					
Slope damage caused by human activity.

Looking west at slope damage on landside slope.

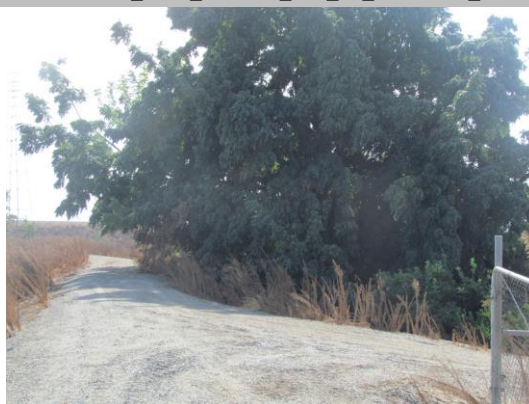
Photo 1 of 1 : SP_2018_RD0524_107_73_20180323_00147.jpg

LM Start	5.44	Rating **	U	Issue No.	73
LM End	5.44	Issue Type +	Ma	Location *	LS
Category	Earthen Levee			GPS Latitude/Longitude	
				Start	End
Item	Trim / Thin Trees			37.880085 °	37.880085 °
				-121.333045 °	-121.333045 °
DWR ID	DWR_RD0524_01_s_2012_73				
Comment Code					
T1 : Trim trees to at least five feet above ground level.					
Inspector Comment					
Untrimmed trees on landside slope.

Looking southwest at large untrimmed tree on landward slope.

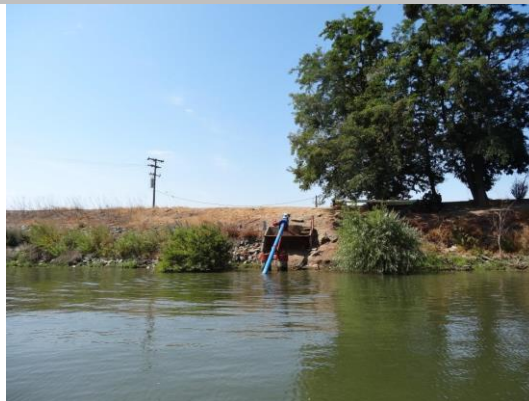
Photo 1 of 2 : SP_2018_RD0524_107_92_20180323_00175.jpg

LM Start	5.53	Rating **	M	Issue No.	92
LM End	5.53	Issue Type +	Ma	Location *	WS
Category	Supplemental			GPS Latitude/Longitude	
				Start	End
Item	DWR Erosion Survey			37.878920 °	37.878920 °
				-121.332670 °	-121.332670 °
DWR ID	RD0524U01RM46.06				
Comment Code					
Inspector Comment					
09/13/2017: No significant change observed.					
07/25/2016: No significant change observed.					
06/24/2015: No significant change observed.					
06/19/2014: No significant change observed.					
08/13/2013: Larger trees are at the levee shoulder, and an irrigation pump station is next to the erosion site. [2017 Site ID:RD0524U01RM46.06]

Front view of the erosion.

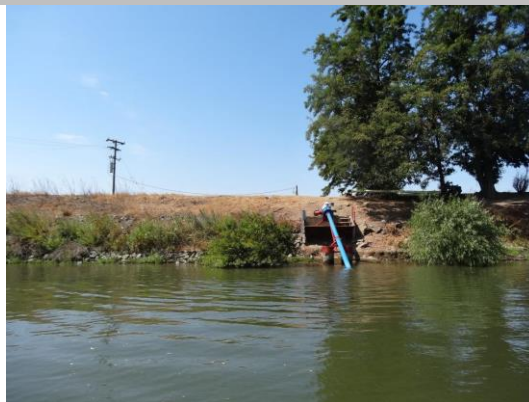
Photo 2 of 2 : SP_2018_RD0524_107_92_20180323_00176.jpg

Close view of the site.

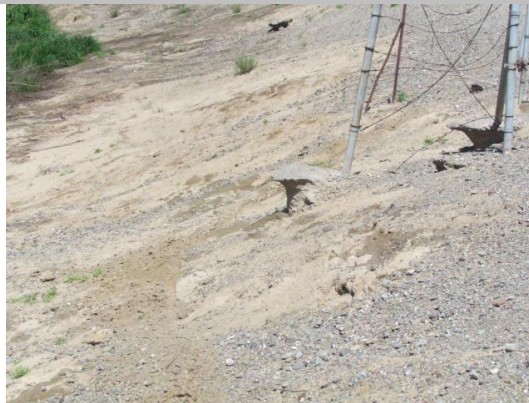
Photo 1 of 3 : SP_2018_RD0524_107_215_20180323_00296.jpg

LM Start	5.64	Rating **	U	Issue No.	215
LM End	5.64	Issue Type +	Ma	Location *	LS
Category	Earthen Levee			GPS Latitude/Longitude	
				Start	End
Item	Slope Stability			37.877378 °	37.877378 °
				-121.332343 °	-121.332343 °
DWR ID	DWR_RD0524_01_s_2016_215				
Comment Code					
S1 : Repair slope instability.					
Inspector Comment					
Levee slope damage is due vehicle traffic and foot traffic. Vehicle traffic created a ramp on landside slope.

Looking north at damage slope on landward slope.

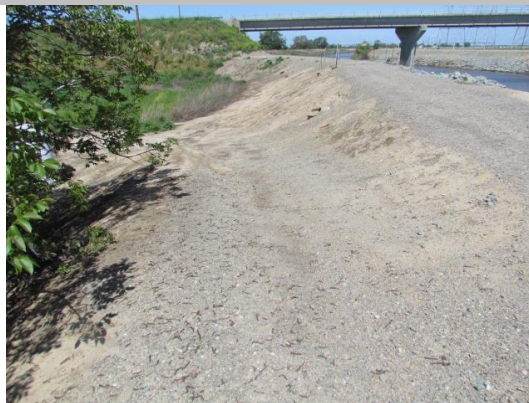
Photo 2 of 3 : SP_2018_RD0524_107_215_20180323_00297.jpg

Looking north at slope damage (ramp) on landward slope.

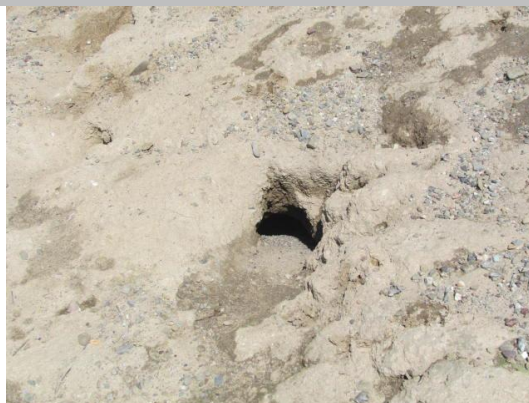
Photo 1 of 2 : SP_2018_RD0524_107_69_20180323_00138.jpg

LM Start	5.64	Rating **	M	Issue No.	69
LM End	5.80	Issue Type +	Ma	Location *	LS
Category	Earthen Levee			GPS Latitude/Longitude	
				Start	End
Item	Animal Control			37.877298 °	37.875073 °
				-121.332343 °	-121.333168 °
DWR ID	DWR_RD0524_01_s_2012_69				
Comment Code					
A3 : No rodents visible, but rodent burrows visible; need to backfill and compact or grout burrows.					
Inspector Comment					
District has grouted rodent holes, but rodents are still present.

Looking south at rodent holes on landward slope.

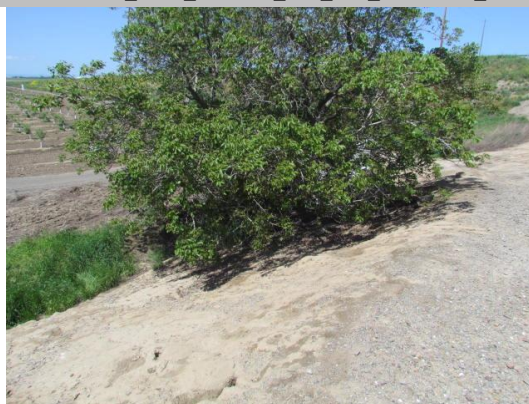
Photo 1 of 1 : SP_2018_RD0524_107_117_20180323_00201.jpg

LM Start	5.64	Rating **	U	Issue No.	117
LM End	5.64	Issue Type +	Ma	Location *	LS
Category	Earthen Levee			GPS Latitude/Longitude	
				Start	End
Item	Trim / Thin Trees			37.877272 °	37.877272 °
				-121.332400 °	-121.332400 °
DWR ID	DWR_RD0524_01_f_2013_117				
Comment Code					
T1 : Trim trees to at least five feet above ground level.					
Inspector Comment

Looking northwest at untrimmed tree on landward slope.

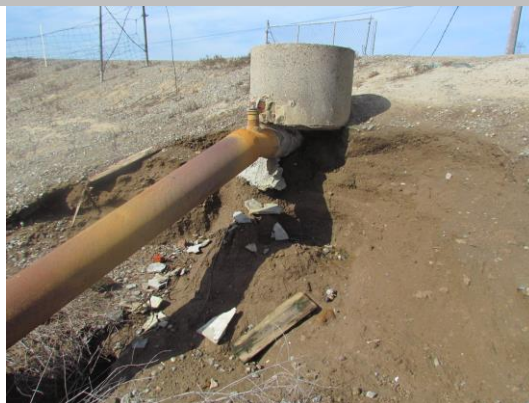
Photo 1 of 3 : SP_2018_RD0524_107_183_20180323_00256.jpg

LM Start	5.81	Rating **	U	Issue No.	183
LM End	5.81	Issue Type +	Ma	Location *	WS
Category	Earthen Levee			GPS Latitude/Longitude	
				Start	End
Item	Erosion / Bank Caving			37.874973 °	37.874973 °
				-121.333227 °	-121.333227 °
DWR ID	DWR_RD0524_01_s_2017_183				
Comment Code					
E2 : Schedule repair of erosion site prior to the next inspection.					
Inspector Comment					
Bank caving on waterside around pipe structure.

Looking west at erosion around pipe and on waterward slope.

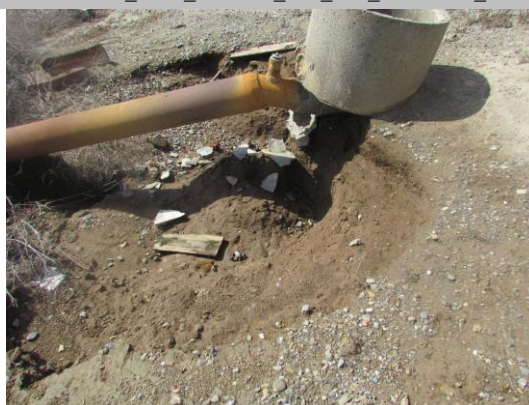
Photo 2 of 3 : SP_2018_RD0524_107_183_20180323_00257.jpg

Looking south at erosion around pipe and on waterward slope.

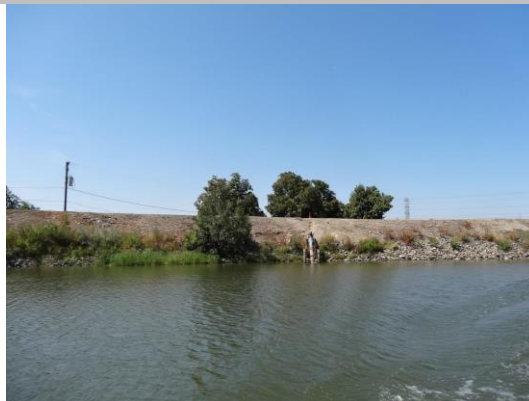
Photo 1 of 2 : SP_2018_RD0524_107_93_20180323_00177.jpg

LM Start	5.86	Rating **	U	Issue No.	93
LM End	5.86	Issue Type +	Ma	Location *	WS
Category	Supplemental			GPS Latitude/Longitude	
				Start	End
Item	DWR Erosion Survey			37.874370 °	37.874370 °
				-121.332850 °	-121.332850 °
DWR ID	RD0524U01RM46.39				
Comment Code					
Inspector Comment					
09/13/2017: No significant change observed.					
07/25/2016: No significant change observed.					
06/24/2015: No significant change observed.					
06/19/2014: No significant change observed.					
08/13/2013: No significant change observed.					
08/07/2012: The erosion is near a water-intake structure. Pipe leakage likely caused the erosion. [2017 Site ID:RD0524U01RM46.39]

Front view of the site.

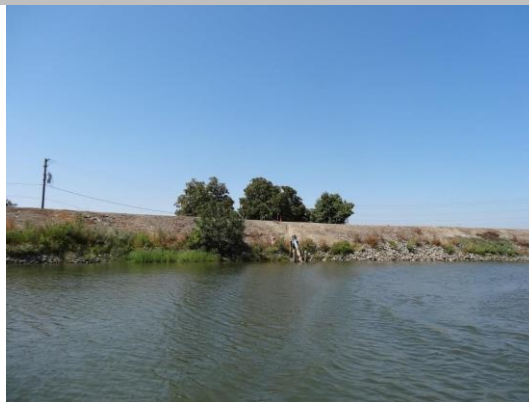
Photo 2 of 2 : SP_2018_RD0524_107_93_20180323_00178.jpg

View of the erosion.

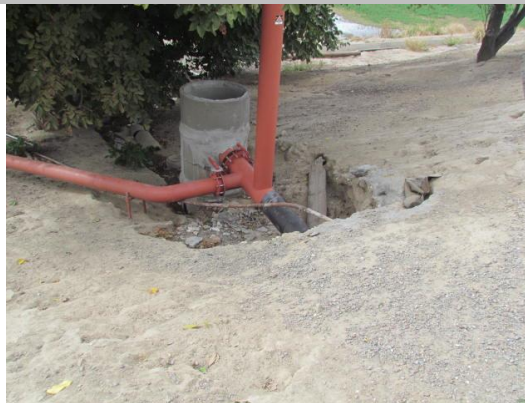
Photo 2 of 3 : SP_2018_RD0524_107_74_20180323_00149.jpg

LM Start	5.87	Rating **	U	Issue No.	74 (cont)	
LM End	5.87	Issue Type +	Ma	Location *	WS	
Category	Earthen Levee			GPS Latitude/Longitude		
				Start		End
Item	Erosion / Bank Caving			37.874202 °		37.874086 °
				-121.333197 °		-121.333153 °
DWR ID	DWR_RD0524_01_s_2012_74					
Comment Code						
E1 : Note and monitor erosion site.						
Inspector Comment						
Erosion on landside slope around intake pipe.

Looking west at erosion around intake pipe on landward slope.

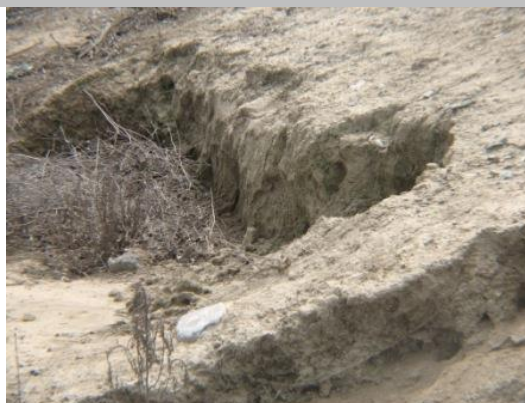
Photo 3 of 3 : SP_2018_RD0524_107_74_20180323_00150.jpg

Erosion at waterward toe and around irrigation pipe at LM 5.92

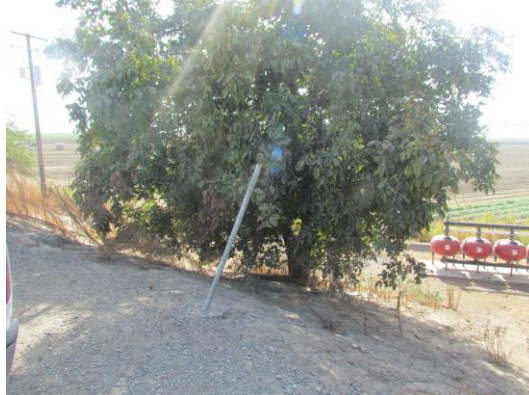
Photo 1 of 1 : SP_2018_RD0524_107_98_20180323_00184.jpg

LM Start	5.87	Rating **	M	Issue No.	98
LM End	5.87	Issue Type +	Ma	Location *	LS
Category	Earthen Levee			GPS Latitude/Longitude	
				Start	End
Item	Trim / Thin Trees			37.874085 °	37.874085 °
				-121.333154 °	-121.333154 °
DWR ID	DWR_RD0524_01_s_2012_98				
Comment Code					
T1 : Trim trees to at least five feet above ground level.					
Inspector Comment					
Untrimmed walnut tree on landside slope.

Looking west at walnut tree on landward slope.

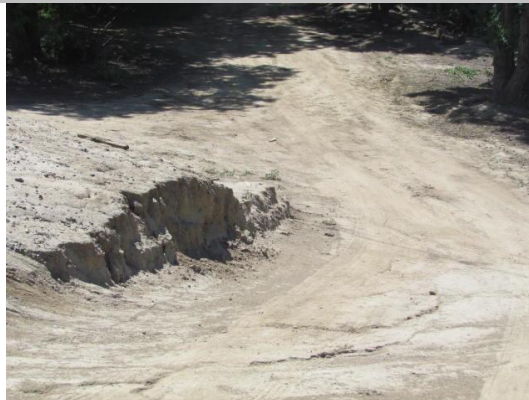
Photo 1 of 2 : SP_2018_RD0524_107_119_20180323_00205.jpg

LM Start	5.89	Rating **	U	Issue No.	119
LM End	5.89	Issue Type +	Ma	Location *	LS
Category	Earthen Levee			GPS Latitude/Longitude	
				Start	End
Item	Slope Stability			37.873893 °	37.873893 °
				-121.332978 °	-121.332978 °
DWR ID	DWR_RD0524_01_s_2012_119				
Comment Code					
S3 : Repair the levee slope damaged by vehicle traffic and prevent access where possible.					
Inspector Comment					
Landowner is using damaged area as a ramp.

Looking west at unauthorized ramp and landside slope damage.

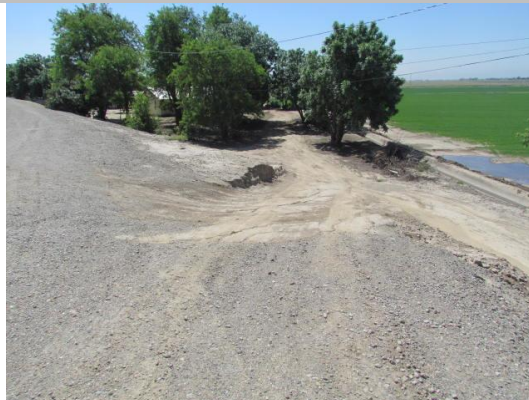
Photo 2 of 2 : SP_2018_RD0524_107_119_20180323_00206.jpg

Looking southwest at damaged slope and ramp on landside slope.

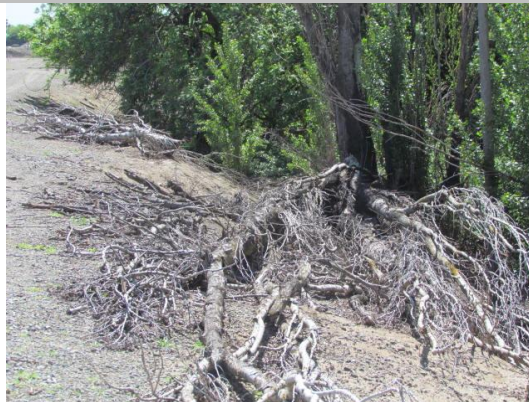
Photo 1 of 4 : SP_2018_RD0524_107_81_20180323_00161.jpg

LM Start	6.15	Rating **	M	Issue No.	81
LM End	6.15	Issue Type +	Ma	Location *	LS
Category	Earthen Levee			GPS Latitude/Longitude	
				Start	End
Item	Encroachments			37.871097 °	37.871097 °
				-121.330100 °	-121.330100 °
DWR ID	DWR_RD0524_01_s_2015_81				
Comment Code					
TR : Tree or limb					
Inspector Comment					
Fallen tree branches and limbs on landside slope.

Looking west at tree branches and limbs left on landward shoulder and slope. (Spring 2016)

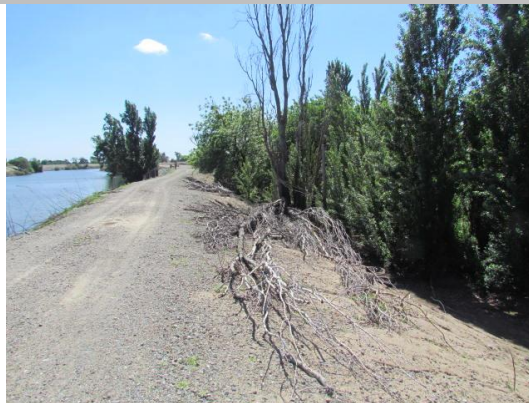
Photo 2 of 4 : SP_2018_RD0524_107_81_20180323_00162.jpg

LM Start	6.15	Rating **	M	Issue No.	81 (cont)	
LM End	6.15	Issue Type +	Ma	Location *	LS	
Category	Earthen Levee			GPS Latitude/Longitude		
				Start		End
Item	Encroachments			37.871097 °		37.871097 °
				-121.330100 °		-121.330100 °
DWR ID	DWR_RD0524_01_s_2015_81					
Comment Code						
TR : Tree or limb						
Inspector Comment						
Fallen tree branches and limbs on landside slope.

Looking south at tree branches and limbs left on landward shoulder and slope. (Spring 2016)

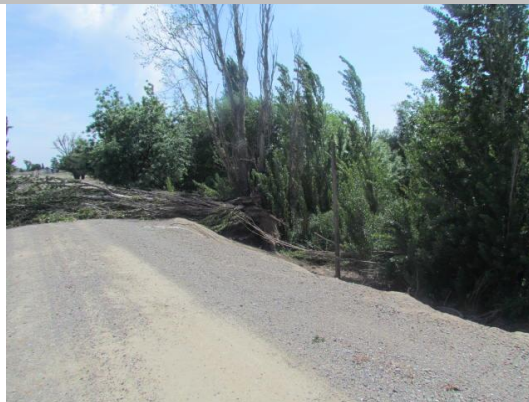
Photo 3 of 4 : SP_2018_RD0524_107_81_20180323_00163.jpg

Looking southwest at large tree across levee crown. (Fall 2015)

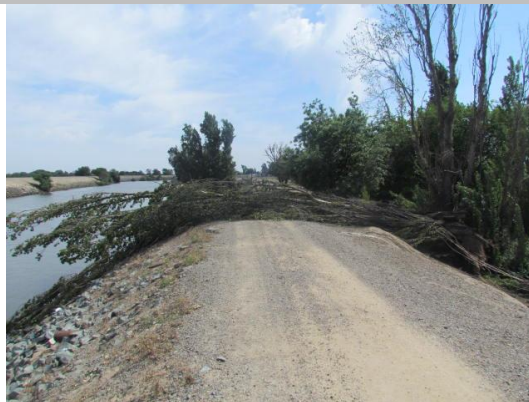
Photo 4 of 4 : SP_2018_RD0524_107_81_20180323_00164.jpg

Looking south at large tree across levee crown. (Fall 2015)
